ROCKMUR FOR SLOPE REHABILITATION

Lee Chee Hai and Oh Yong Ching
Nehemiah Reinforce Soil Sdn. Bhd., Selangor, Malaysia

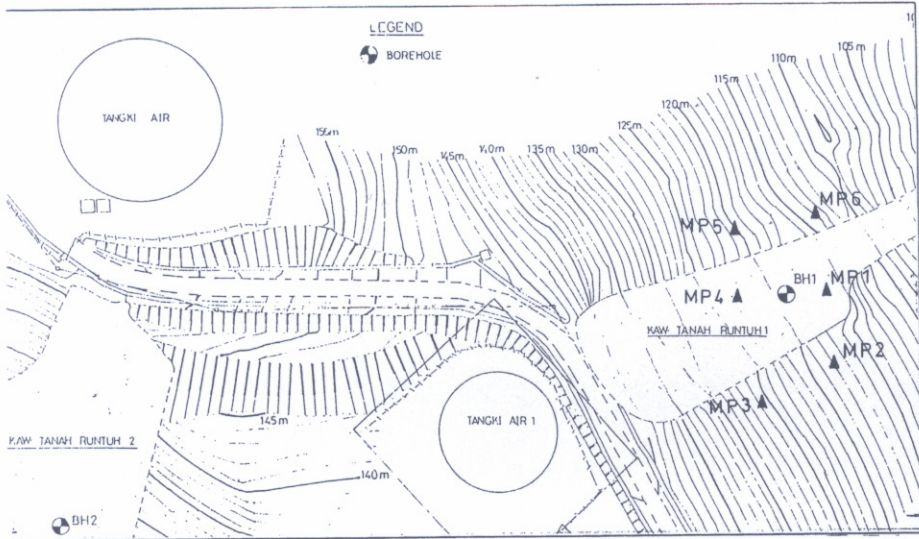
Fig. 1 Location of Landslide

An access road leading to a new 4.54 ML water reservoir for a water supply scheme in Maran, Pahang was completed in February 1992. During the monsoon season of December 1994, the slope adjacent to the access road slumped carried with it about 700 m³ of earth. The location and extend of the failed slope is shown in Fig. 1.

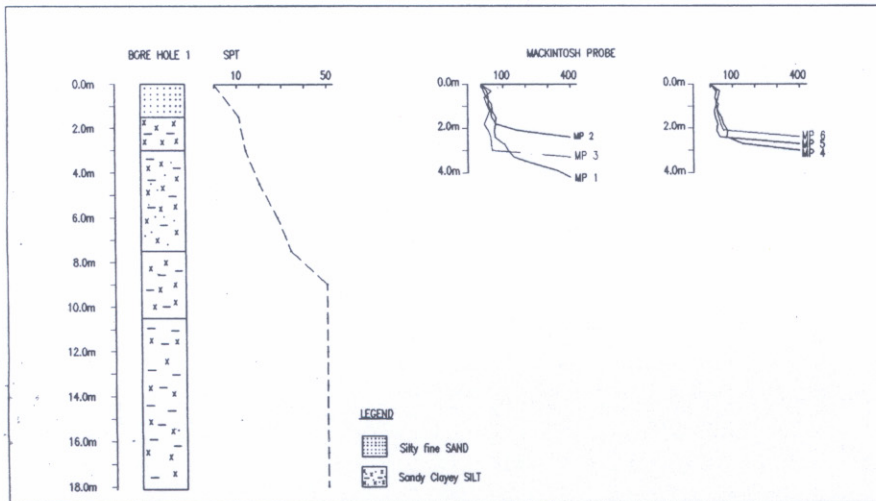
Fig. 2 Borehole Log and Mackintosh Probe Results

A simple site investigation was carried out to determine the subsoil condition and cause of failure. One borehole was sunk to a depth of 18 m. Six MacKintosh probes were carried down to point of refusal. The layout plan of the location of the borehole and the probes are shown in Fig. 1. The borehole log and the probe results are shown in Fig. 2. From the borehole, it is seen that the top 8 m consist of residual soil underlain by highly decomposed sandstone with SPT value well exceeding 50 blows. The probe results show that the point of refusal is met at approximately 3.0 m depth where the blow count exceeds 400 blows per foot. Some water was found seeping out at 6 m below the formation level of the road.

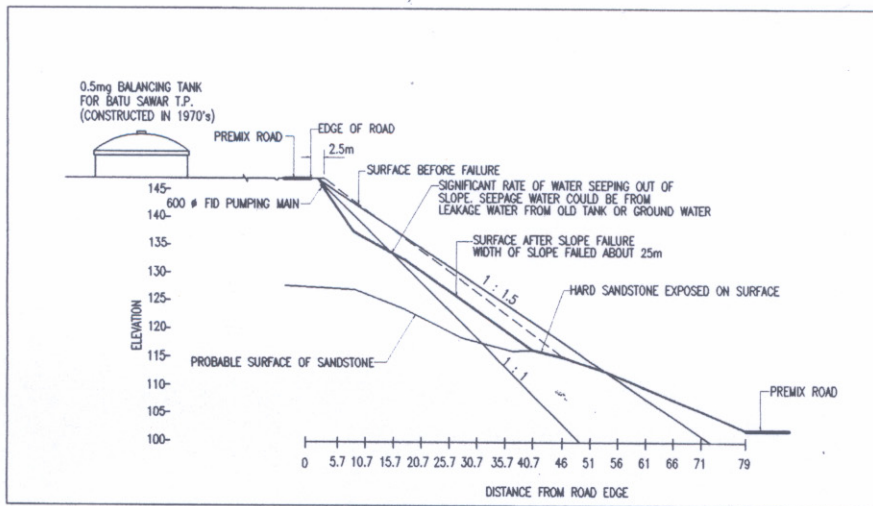
Fig. 3 Typical Section of the Failed Slope

From the site investigation results and the on site inspection, it is obvious that the failure is of the translational type that is common among residual soils. A typical section of the failed slope is shown in Fig. 3. The failure plane is approximately 3 m below the ground surface dipping at an angle of more or less parallel to the gradient of the existing slope before failure. The width of the failure is about 25m over an inclined slope of about 90m. About 700 m³ of material has slumped and slide down the slope. A photo of the failed slope is shown in Fig. 4. The likely cause of failure is due to the saturation of interparticular pores of the residual soil as a result of the infiltration of the monsoon rain water.

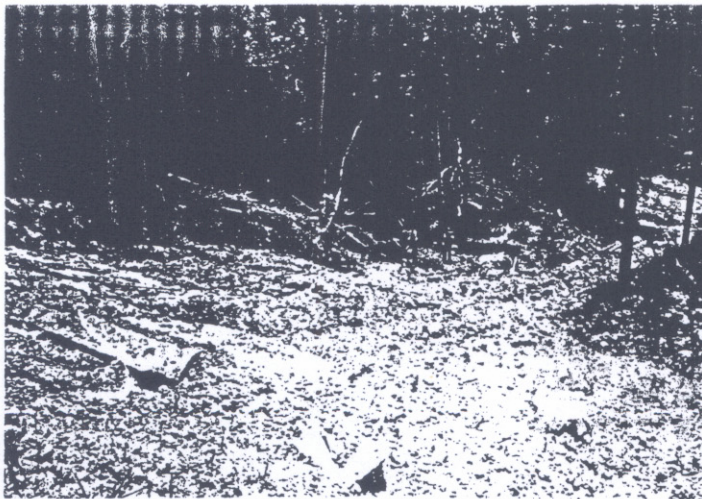
Fig. 4 Photo of Failure Slope
