REPAIR OF ROAD EMBANKMENT FAILURE USING REINFORCED SOIL WALL

Chin Tat Hing Perunding Menara Sdn. Bhd.

Jason Khor Lee Chong, Tan Cheng Chong, Nehemiah Lee Chee Hai Nehemiah Reinforced Soil Sdn. Bhd.

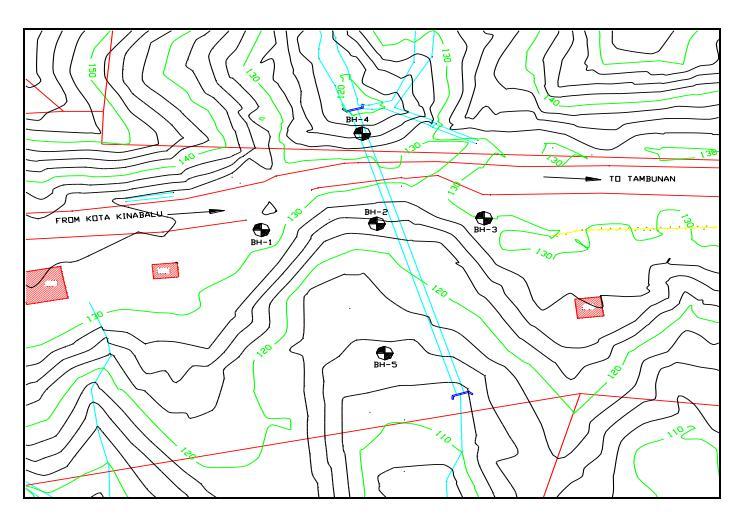
FIGURE 3 : SITE PLAN AND BORE HOLE LOCATION

The road at this location traverses alongside cut slopes hugging to the Crocker Range formation towards a southeasterly direction to Tambunan (Fig 3). The road traverses through a rolling/mountainous terrain. At the failed area, the road traverse across a gorge connecting two hills in the south (Moyog end) and north (Tambunan end) respectively. At the location of the crossing the gorge is some 25 meters across. The existing form of crossing across the gorge is by embankment fill at approximately 12 meters in height. A CMP culvert 914mm diameter is laid at the bottom of the embankment fill to cater for the drainage. The distance of the inlet end of the culvert from the existing road centerline is approximately 12 meters and the outlet end from the existing center line is about 40 meters away.

The concave terrain by the two hills adjacent to the gorge contributes to the surface runoff and the formation of a stream perpendicular to the existing road alignment. The flow in the stream is permanent and erosion gullies are seen to have made their permanent mark in the terrain.

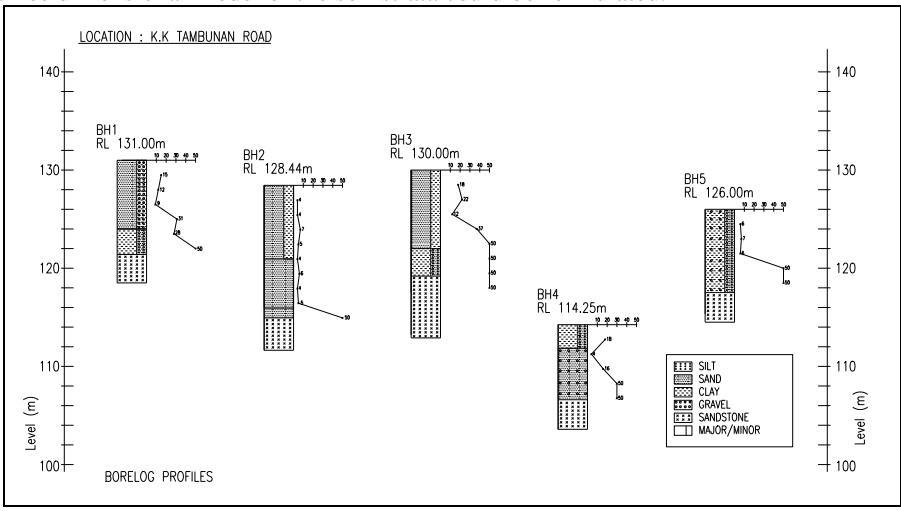
FIGURE 4 : BOREHOLE LOG

The subsoil investigation work was planned based on the survey plan. It was planned that 5 boreholes to be sank at the site. 3 numbers were located along the center line of the road and 2 numbers at the upstream and downstream of the embankment (Fig. 3). The borehole log results are shown in Fig. 4. From the relative depth of the subsoil information, a three dimensional model of the soil strata could be formulated.

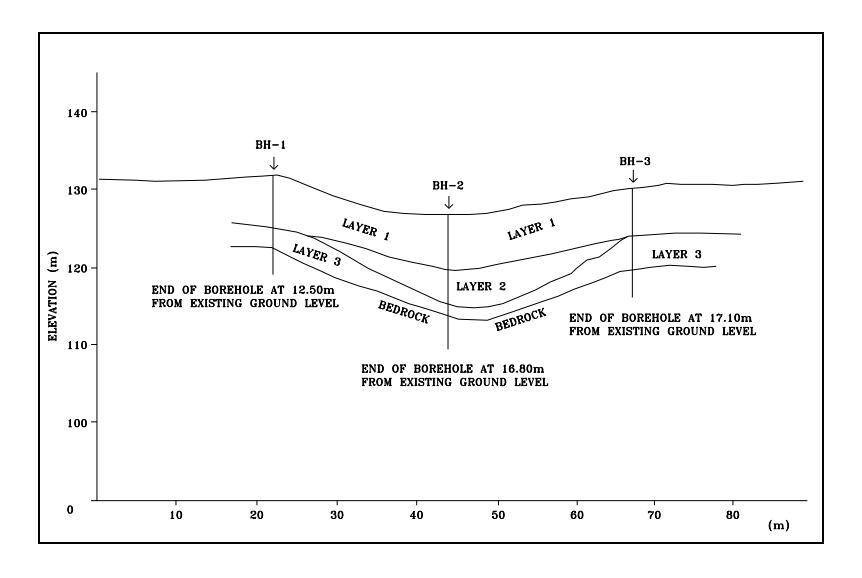
FIGURE 5 : SUBSOIL PROFILE (BH1, BH2, BH3)

The road embankment was constructed across the deep valley. The imported embankment material was simply backfilled and constructed on the existing valley floor. The borehole logs revealed that the subsoil profile of the slope (Fig 5 and Fig 6). The rock level was considered sloping generally along the center line of the valley.

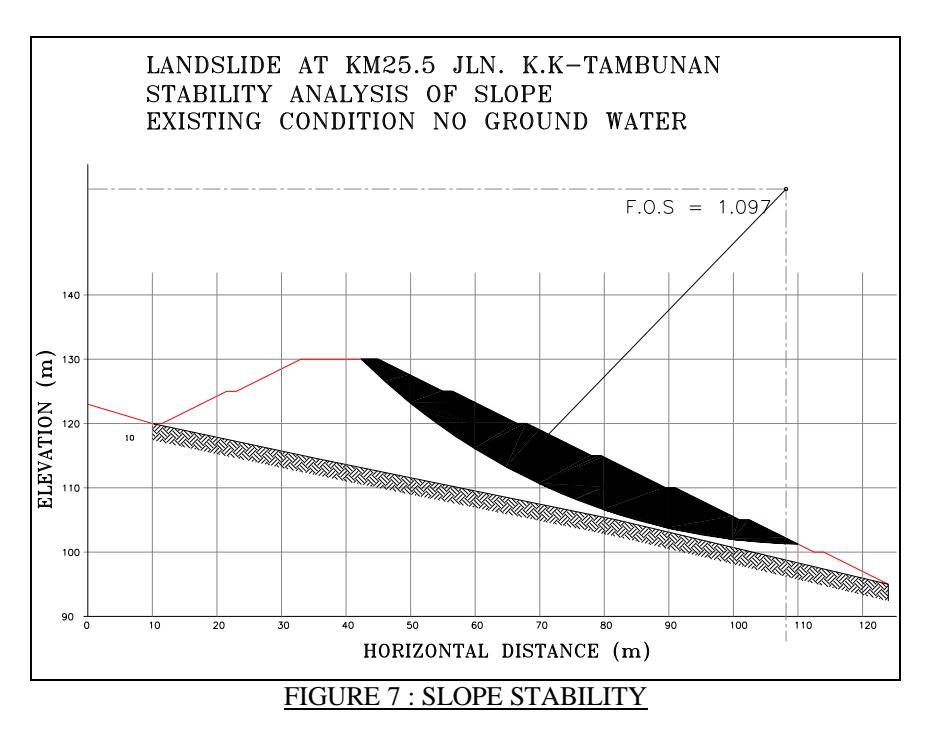
The original embankment slope (Fig 7) was reconstructed and modeled with different ground water conditions. The result showed that the slope was marginally stable with safety factor of 1.097 under normal or dry condition. However, the slope became unstable when the ground water raised up to the height of 1.5 meters inside the embankment.

Based on the above findings it was concluded that the failure of the embankment slope was due to the low soil strength being used for the embankment construction in the first place coupled with the built up of the ground water level in the period of heavy downpour. The clogging of the culvert by debris could contribute the built up of the ground water level inside the embankment.

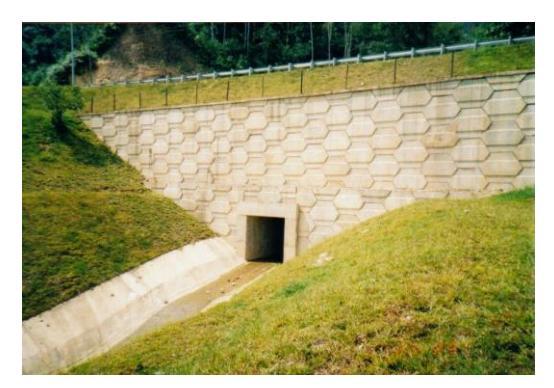
Two Nehemiah walls containing the road embankment with a box culvert situated in the middle were successfully constructed in February 2001 despite the challenges of a very deep valley and heavy rainfall intensity within that area. It provides a cost effective and quick solution to embankment failure problem which is common in Malaysia with her intensive rainfall. Todate, the completed Nehemiah embankment walls are performing satisfactorily. (see Figure 14 & 15)

Figure 14 : Picture of Completed Nehemiah Wall at Outlet

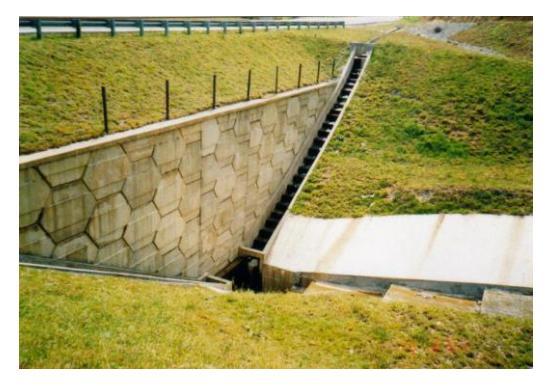
Figure 15 : Picture of Completed Nehemiah Wall at Inlet
