REPAIR OF ROAD EMBANKMENT FAILURE USING REINFORCED SOIL WALL

Chin Tat Hing Perunding Menara Sdn. Bhd.

Jason Khor Lee Chong, Tan Cheng Chong, Nehemiah Lee Chee Hai Nehemiah Reinforced Soil Sdn. Bhd.

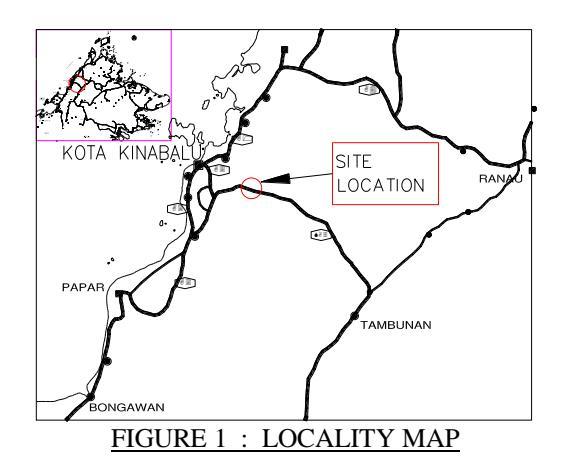
Kota Kinabalu – Tambunan road is major trunk road of 80 Km long connecting the west coast to the interior areas of Sabah ($\underline{Fig 1}$). It begins from Kota Kinabalu traverses eastwardly toward the Crocker Range. The road ascends slowly to 2000 meters above the mean sea level in mid way and then continues to descend to Tambunan town.

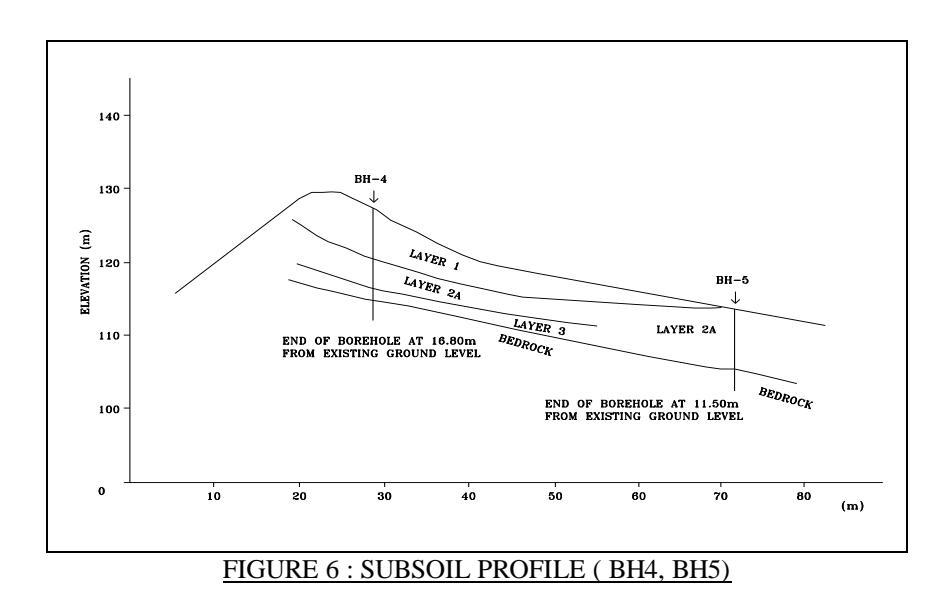
The road embankment was constructed across the deep valley. The imported embankment material was simply backfilled and constructed on the existing valley floor. The borehole logs revealed that the subsoil profile of the slope (Fig 5 and Fig 6). The rock level was considered sloping generally along the center line of the valley.
